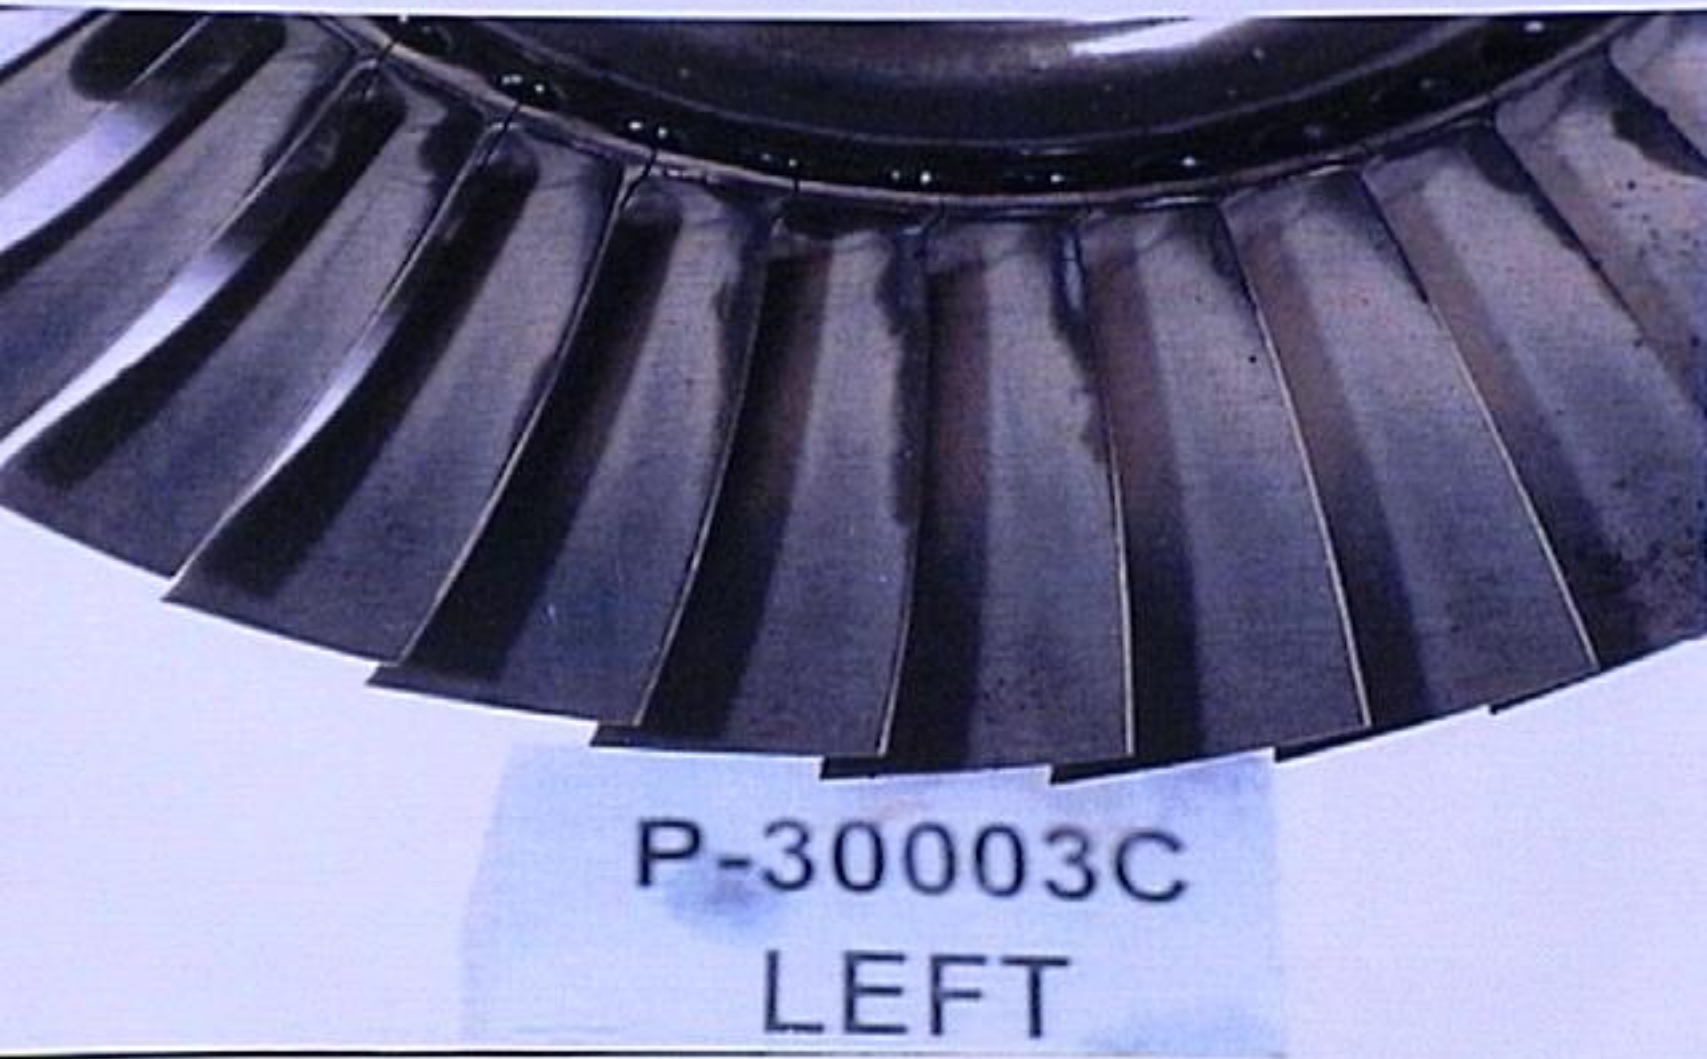
Figure 50. Metal Spray Deposits on the Third-Stage Turbine Blades
